Assessment of Dam Safety

Coal Combustion Surface Impoundments (Task 3)

PacifiCorp

Naughton Power Station

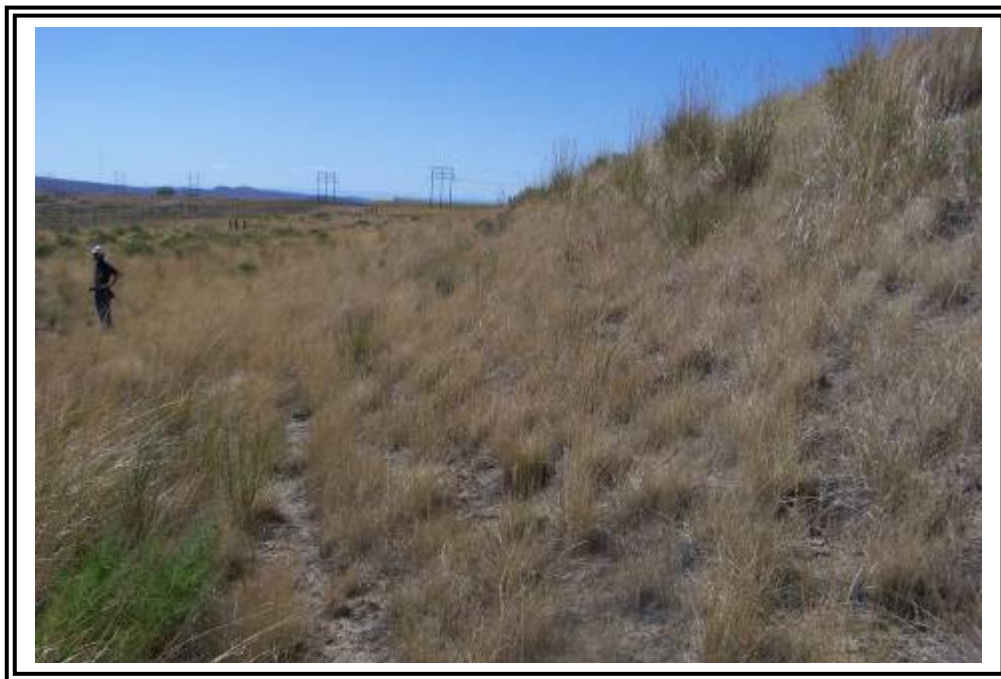
40

Downstream toe and slope at south end of east dike looking south.

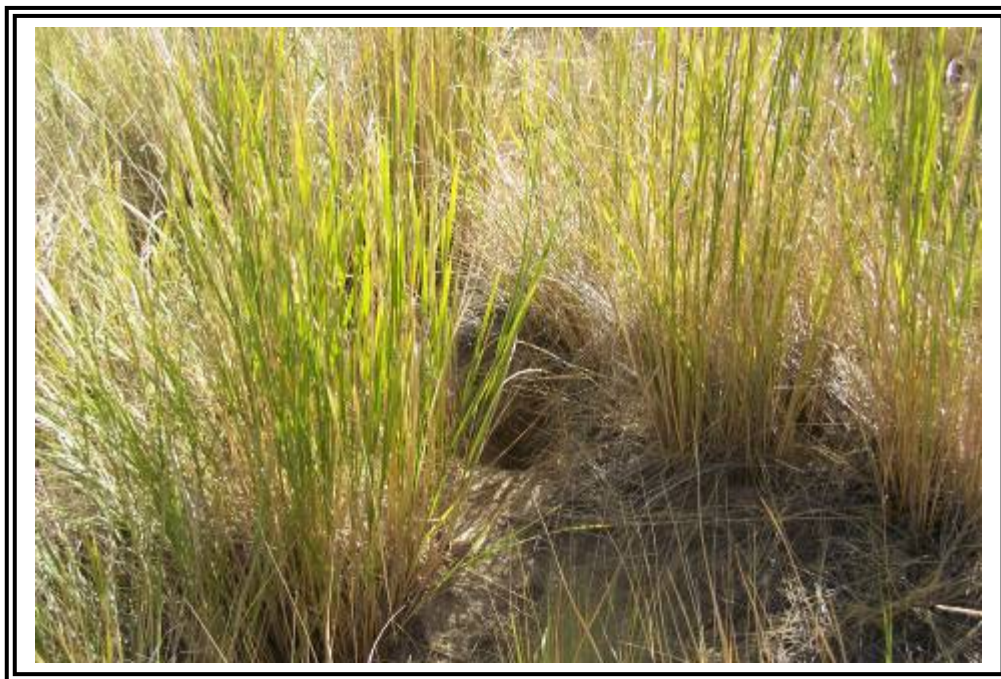
44

Animal burrow on east dike.

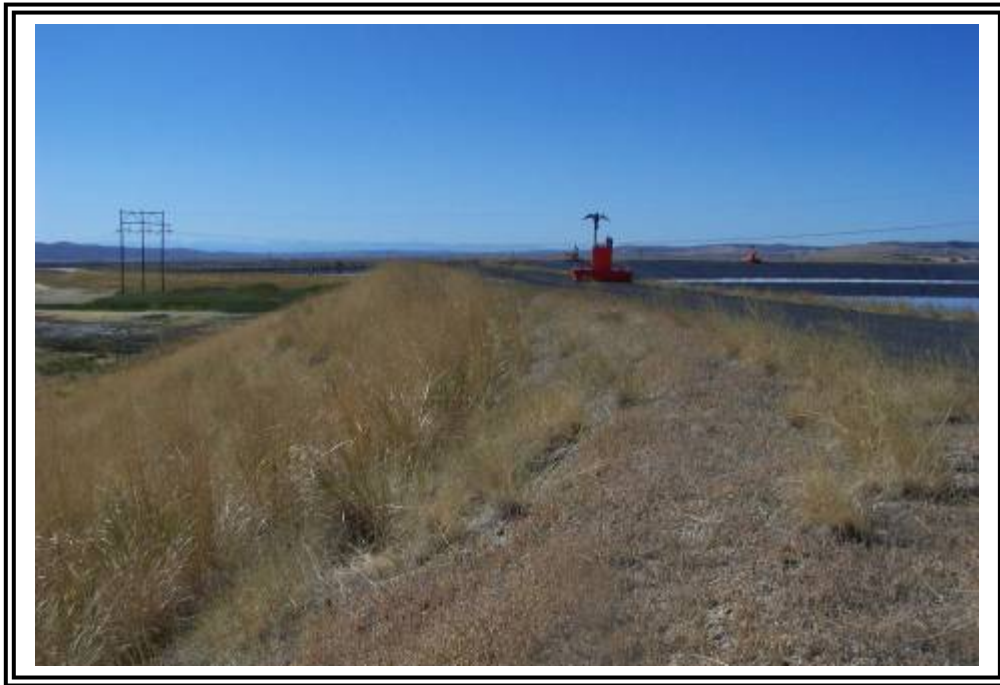
45

Downstream slope of east dike looking south.

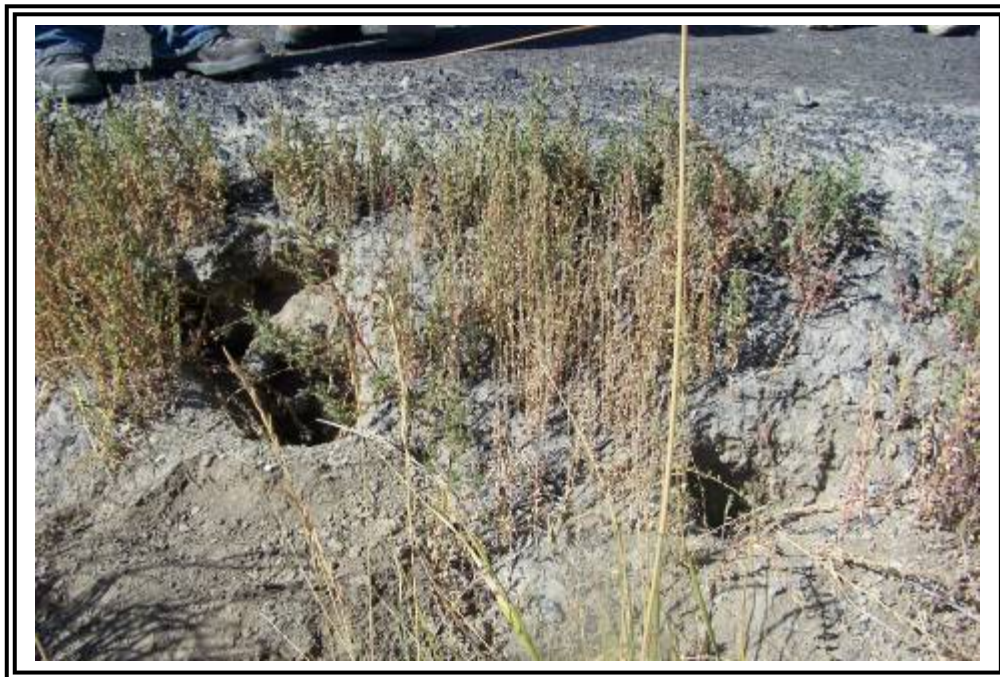
46

Animal burrows.

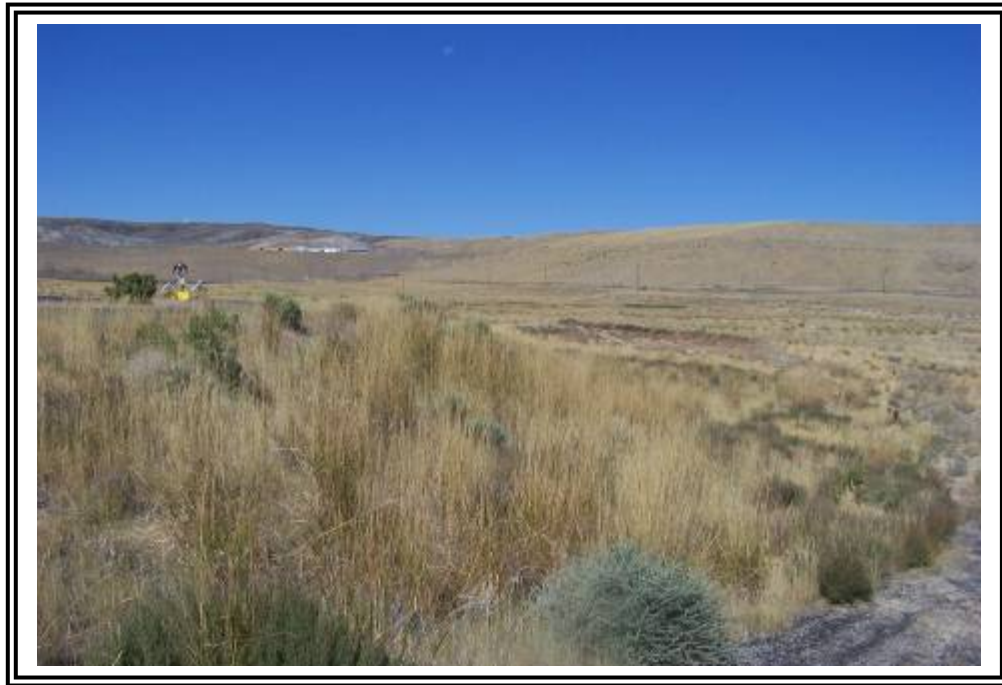
47

West end north dike looking west.

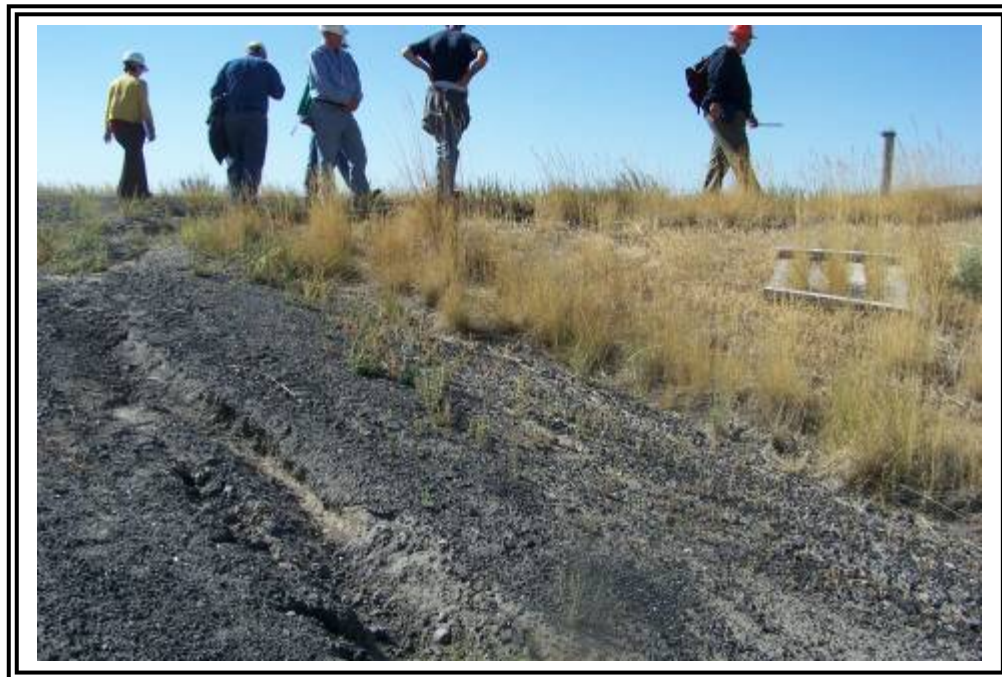
48

Erosion rivulet at access road ramp at west end of north dike.

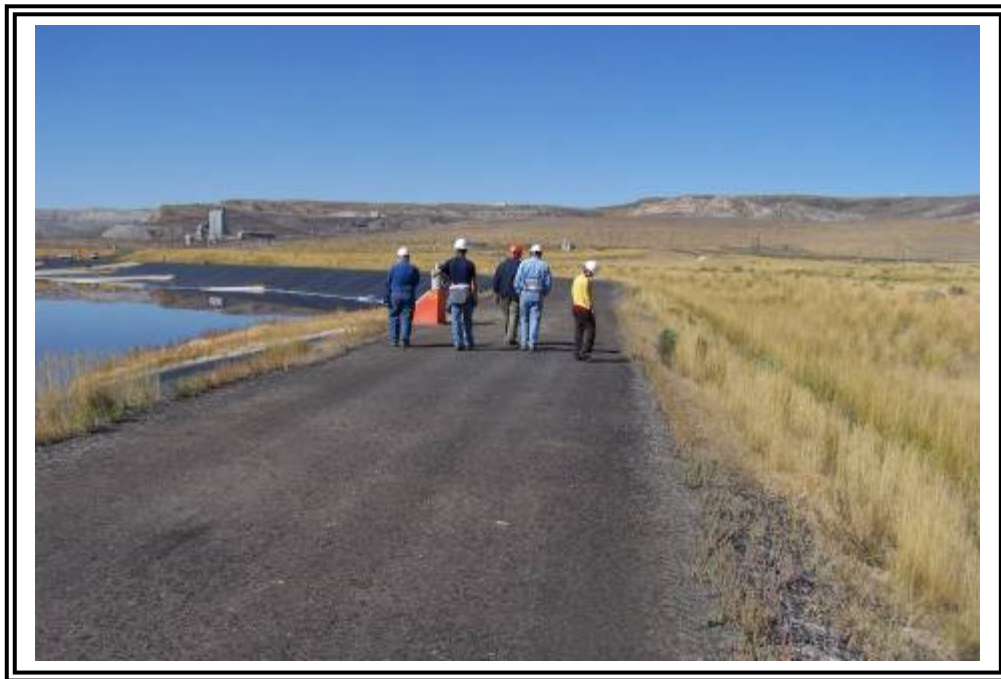
50

Crest of north dike looking northwest. Blends into natural ground.

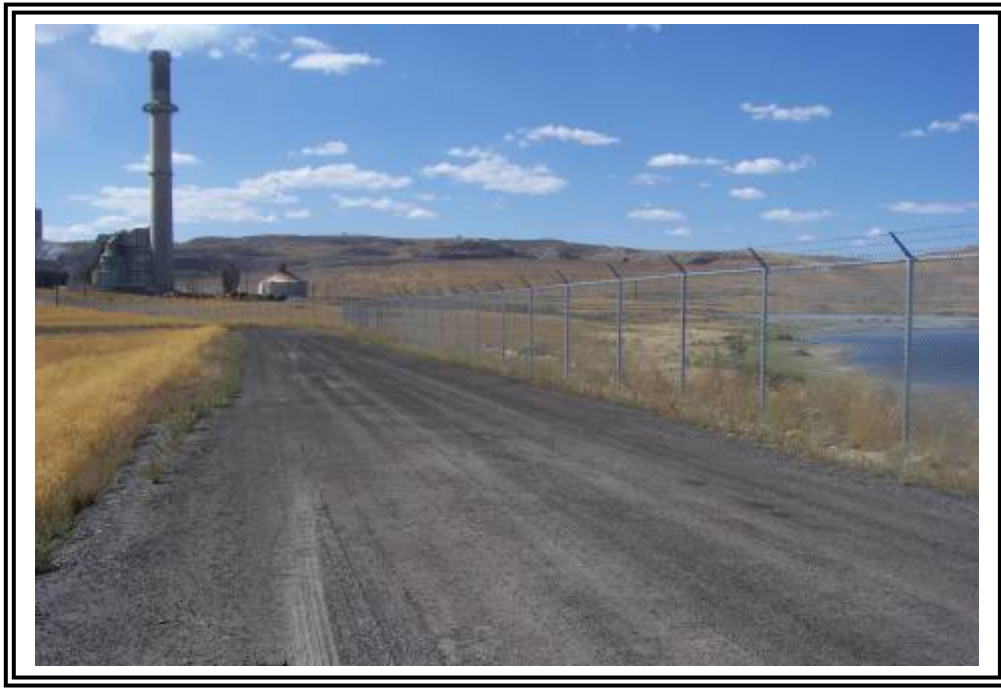
The crest alignments of the North Ash Pond Intermediate and Main dikes do not appear changed from historic site plans. Photos 51 and 52 show typical conditions of the Intermediate Dike Crest. Photo 72 shows the crest of the Main Dike. The access road to the Naughton Power Station crosses the Main Dike. Therefore the crest is about 60 feet wide. The crest of the East Saddle Dike is shown in Photo 88.

South abutment of Intermediate Dike looking west.

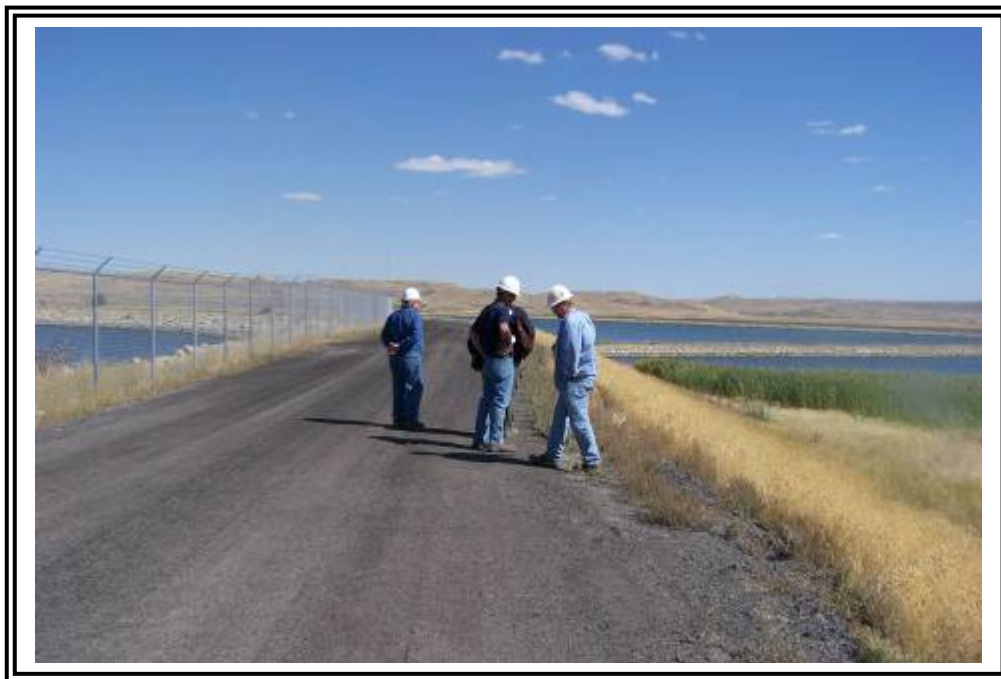
52

Crest of south end of Intermediate Dike looking east.

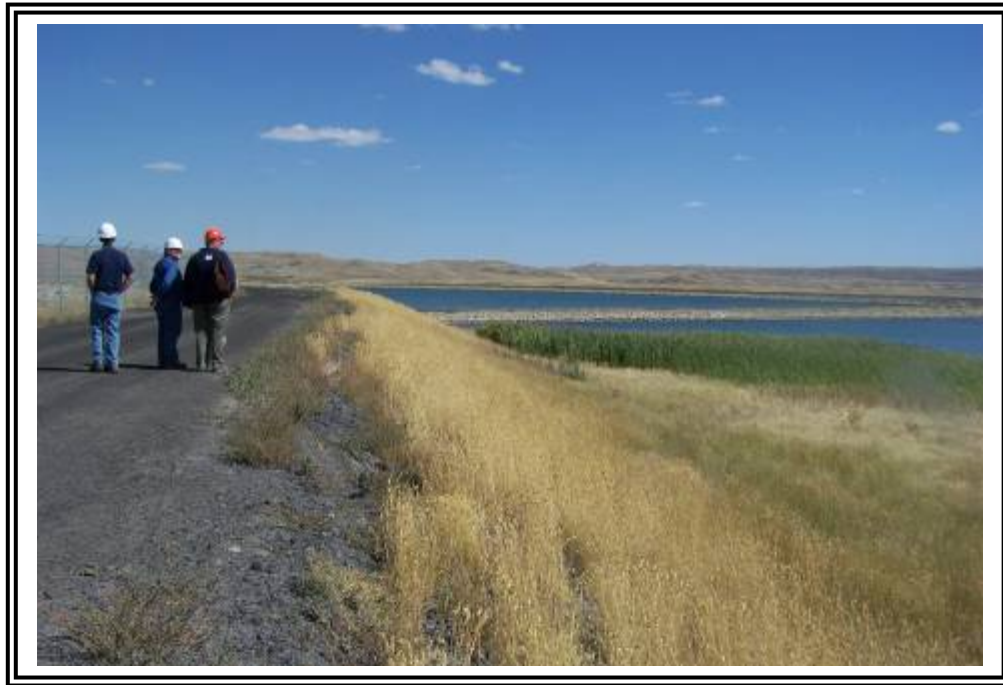
53

Downstream slope of Intermediate Dike looking east.

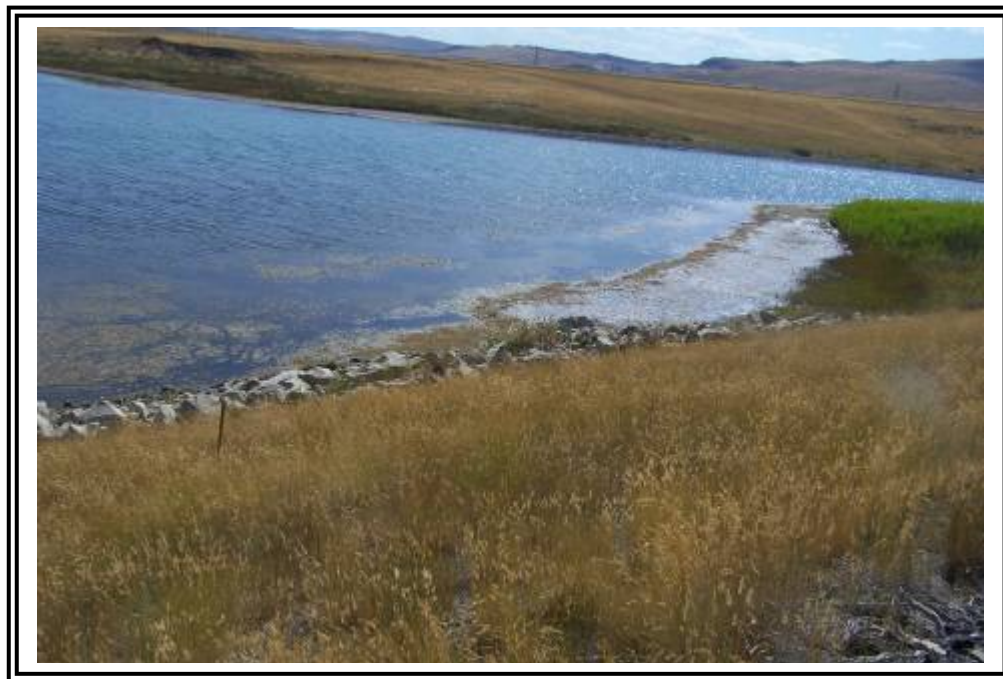
54

Clear water pond at toe of south portion of Intermediate Dike.

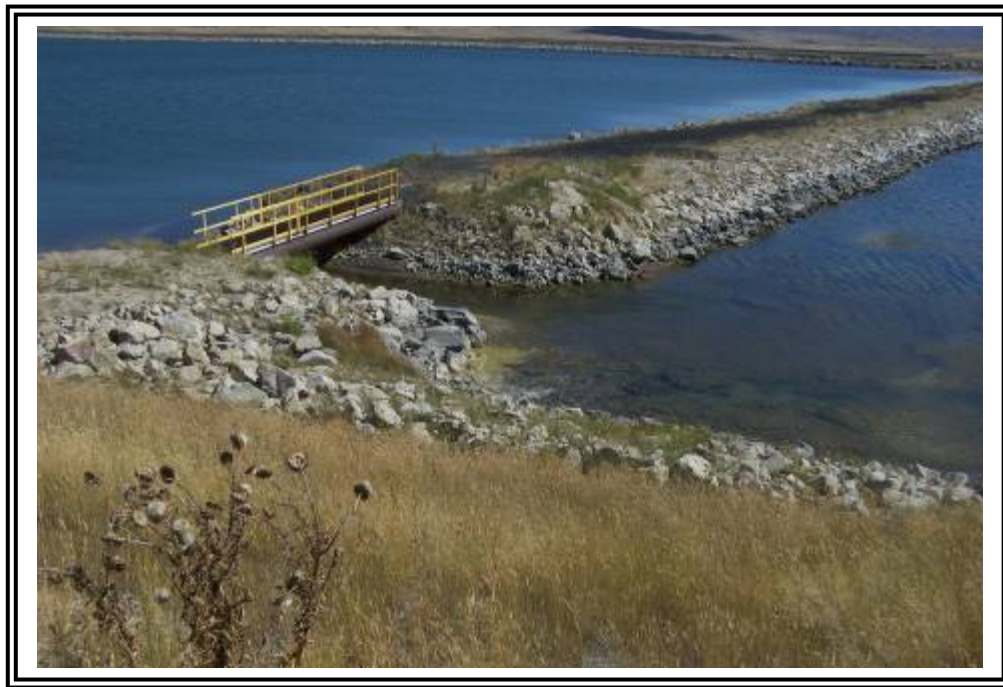
55

Breached dike separating clear water pond from recycle pond.

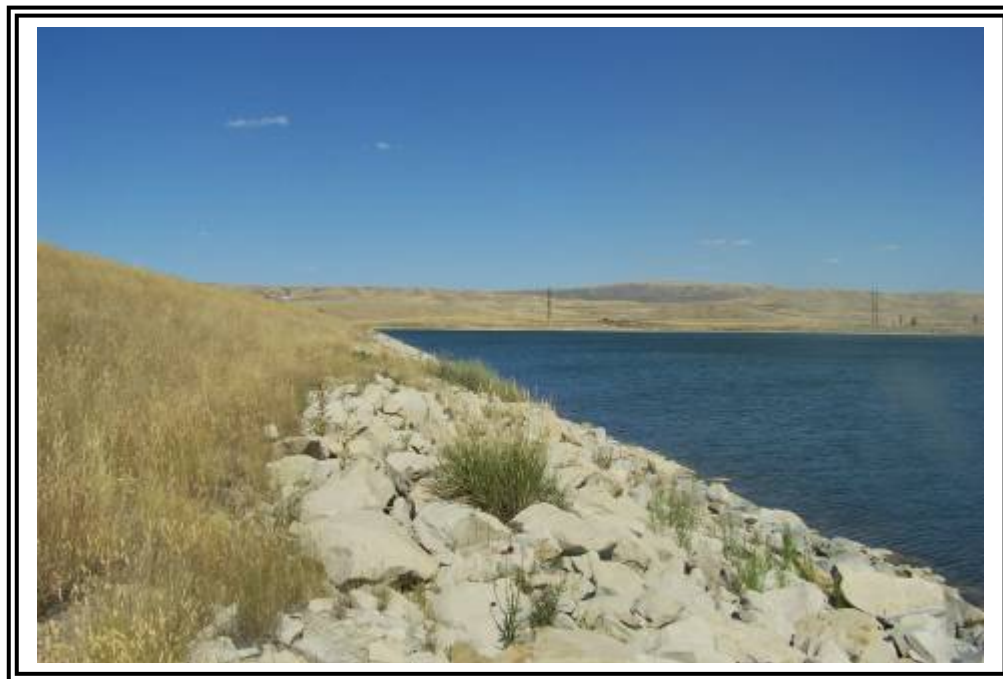
56

Downstream slope of Intermediate Dike looking northeast.

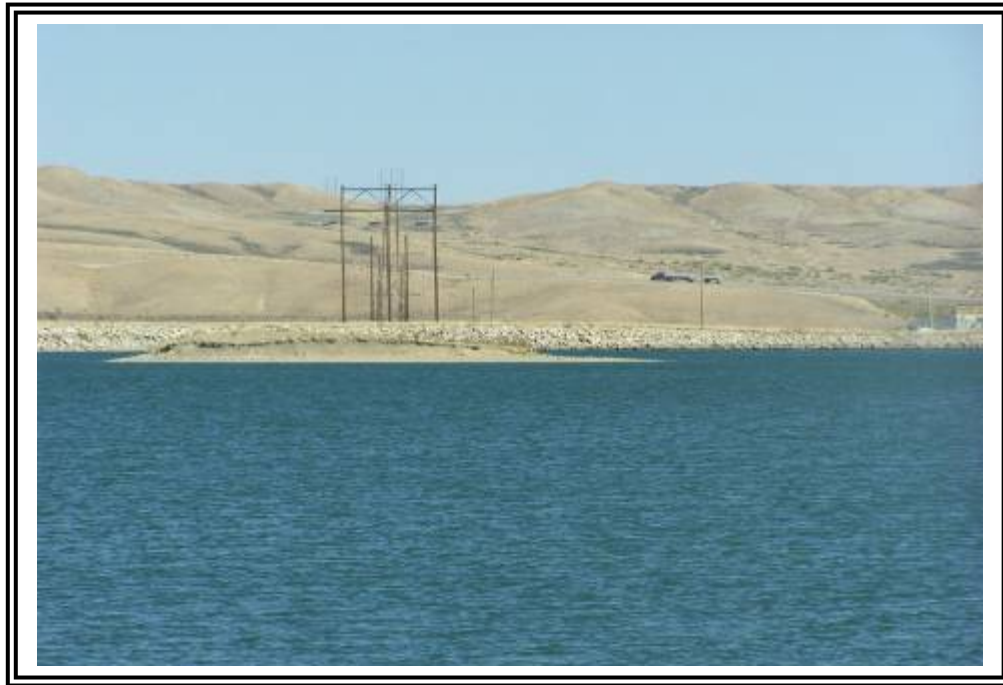
57

Island in clear water pond maintained for bird nesting habitat.

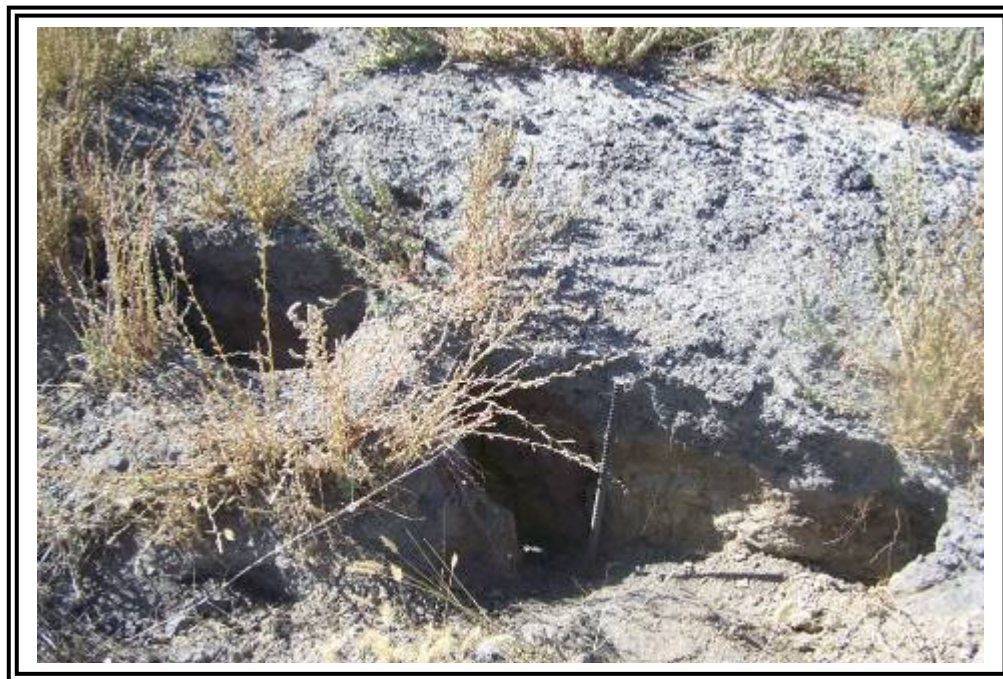
Animal burrows were observed in several locations on the downstream slope of the intermediate dike such as shown in Photos 58 and 68. Near the northeast corner of the Intermediate Dike, a crack was observed adjacent to an animal burrow as shown in Photo 65. The crack appeared to be related to the grading of the access road material.

Animal burrows on downstream slope of Intermediate Dike.

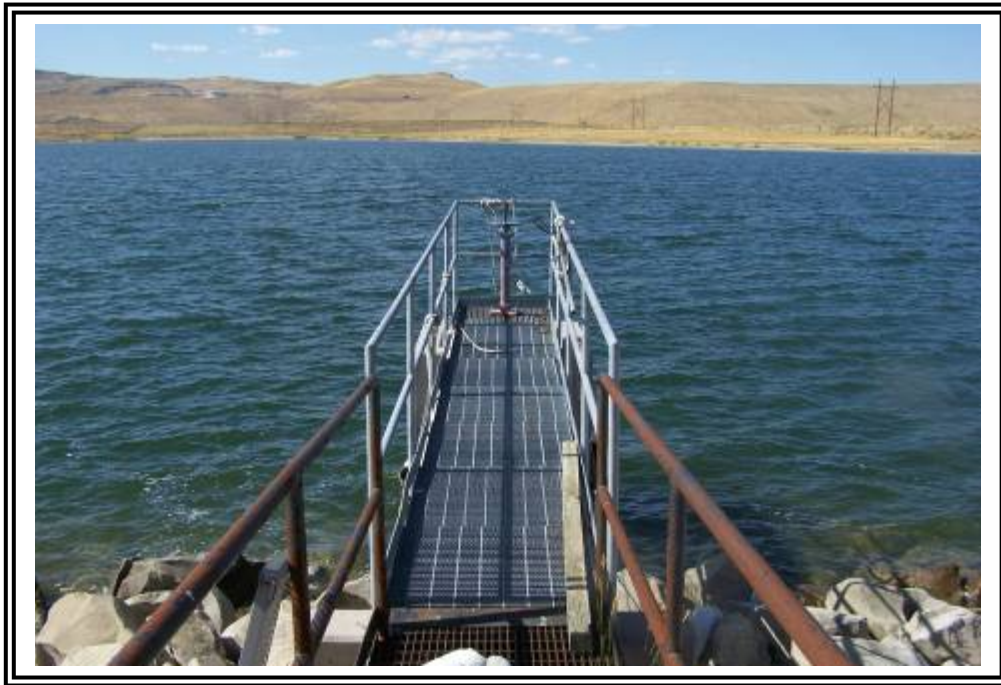
59

Decant structure in Primary Pond (looking northwest).

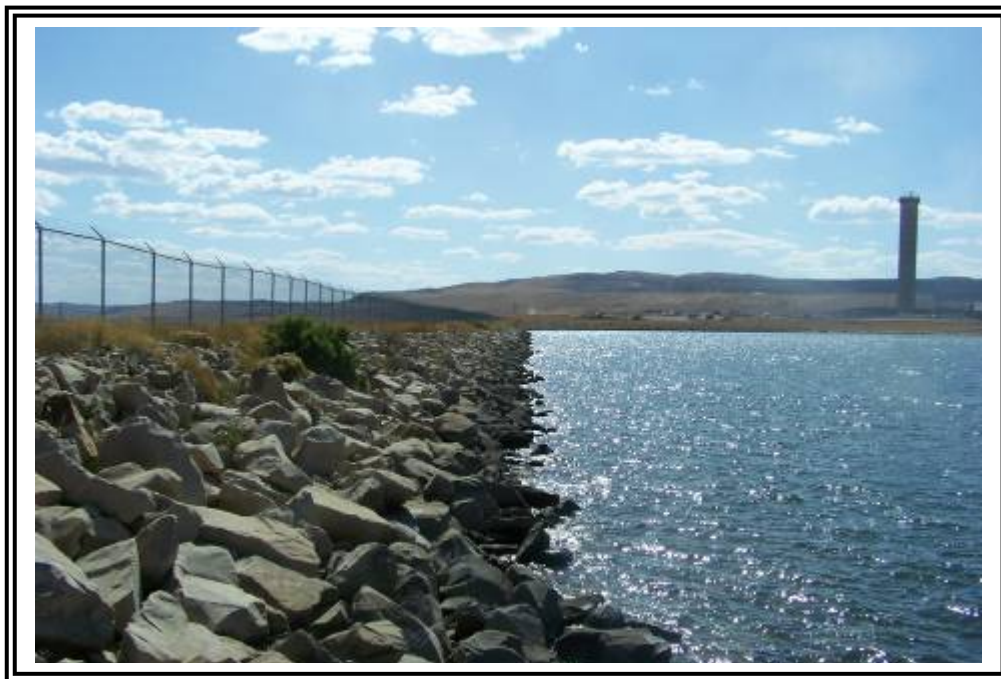
The upstream slope of the Intermediate Dike is covered in rip rap as shown in Photo 60 and 61. This slope is uniform and well maintained although occasional shrubs were observed growing through the rip rap. The downstream slope is vegetated with crested wheatgrass. Isolated sage bushes were observed as shown in Photo 64. Where the downstream slope is adjacent to the clearwater pond, rip rap protection armors the lower portion of the slope as shown in Photo 56. Away from the Clearwater pond the slope is fully vegetation as shown in Photo 66.

Upstream slope of Intermediate Dike looking southwest.

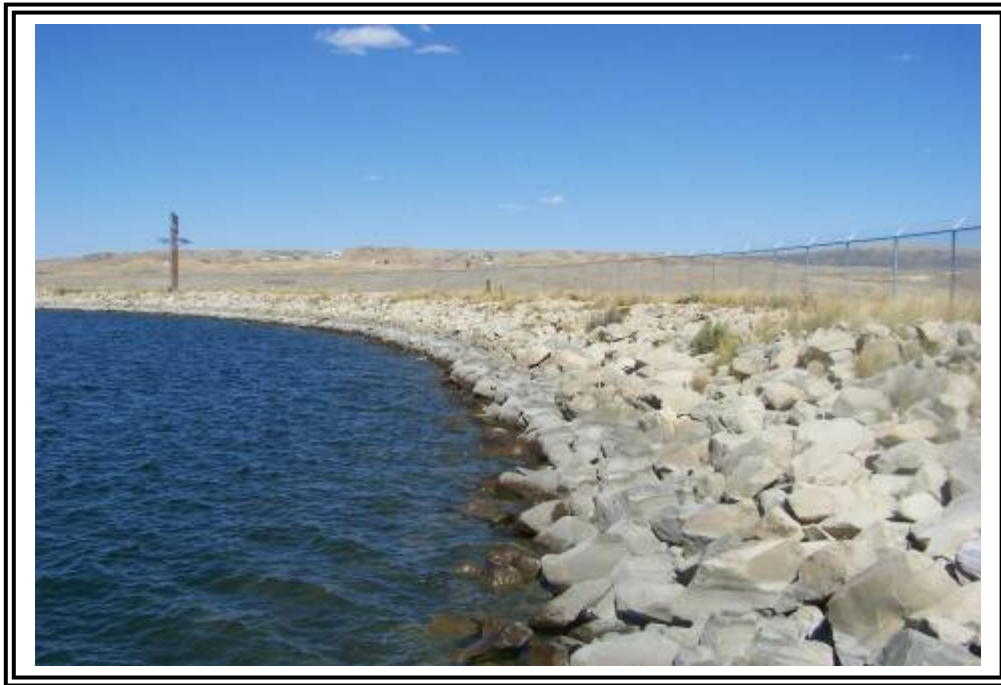
61

Upstream slope of Intermediate Dike looking northeast.

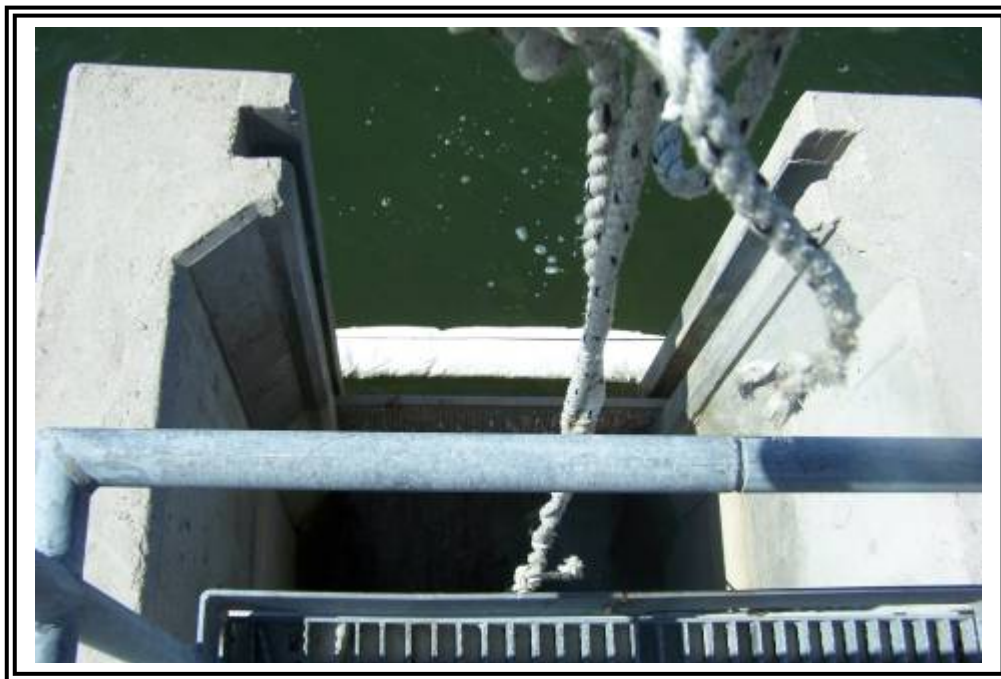
62

Decant structure in Primary pond.

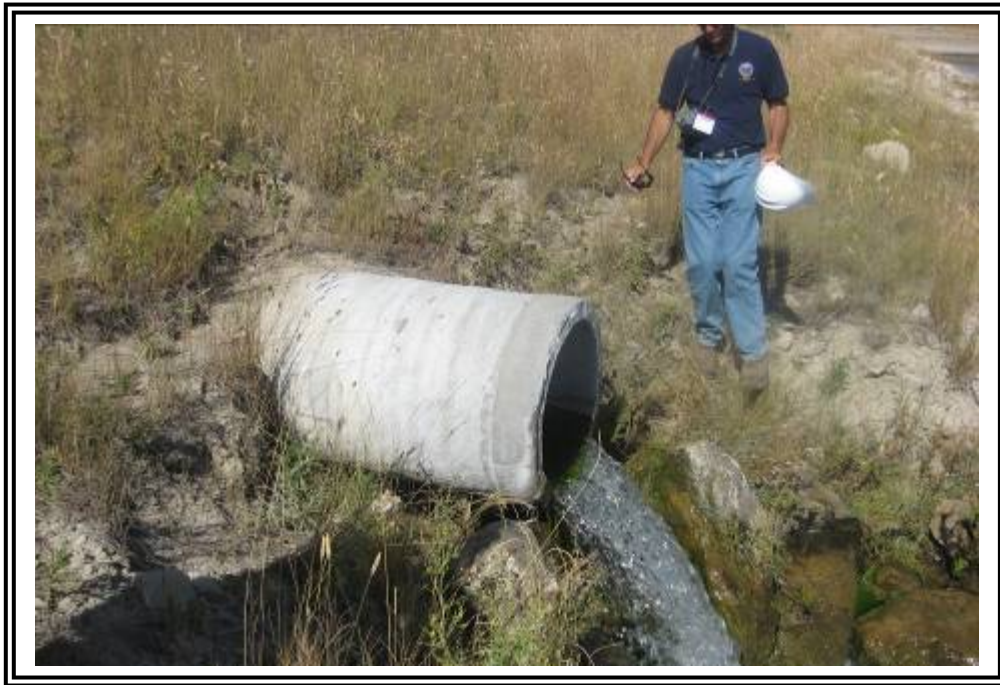
63

Discharge from Primary Pond into clear water pond.

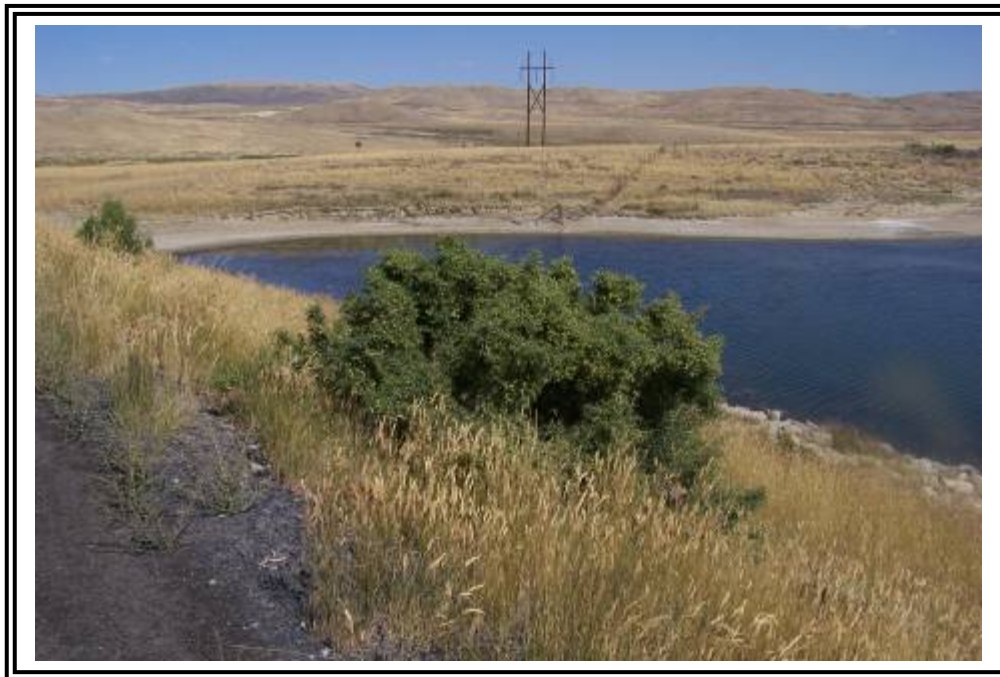
64

Sage brush on downstream slope of Intermediate Dike.

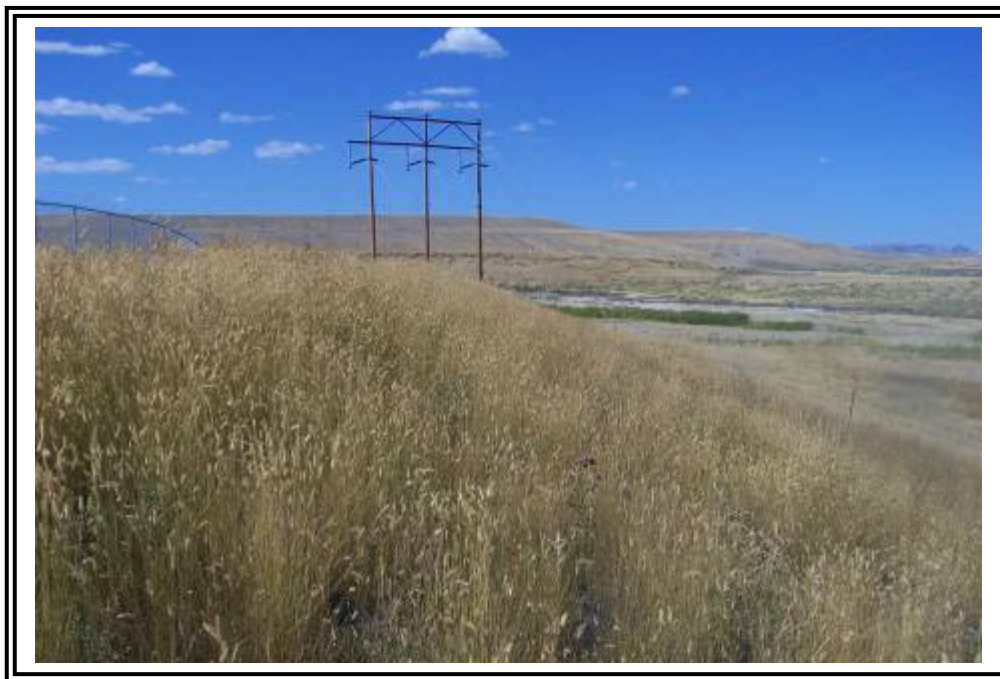
66

Downstream slope at northeast corner of Intermediate Dike looking north.

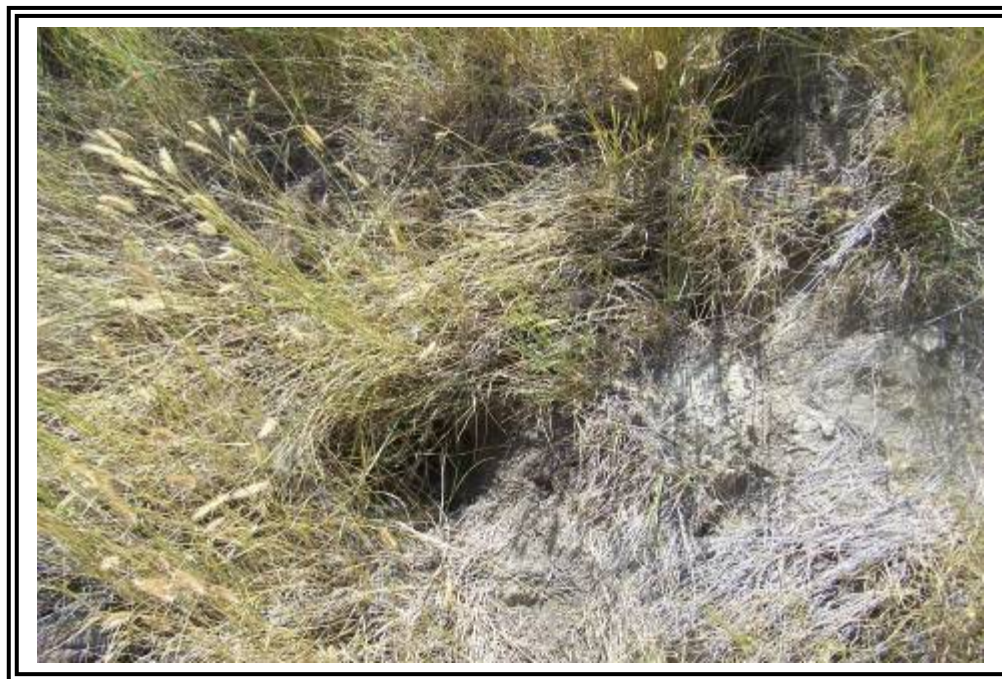
68

Animal burrow on north end of Intermediate Dike.

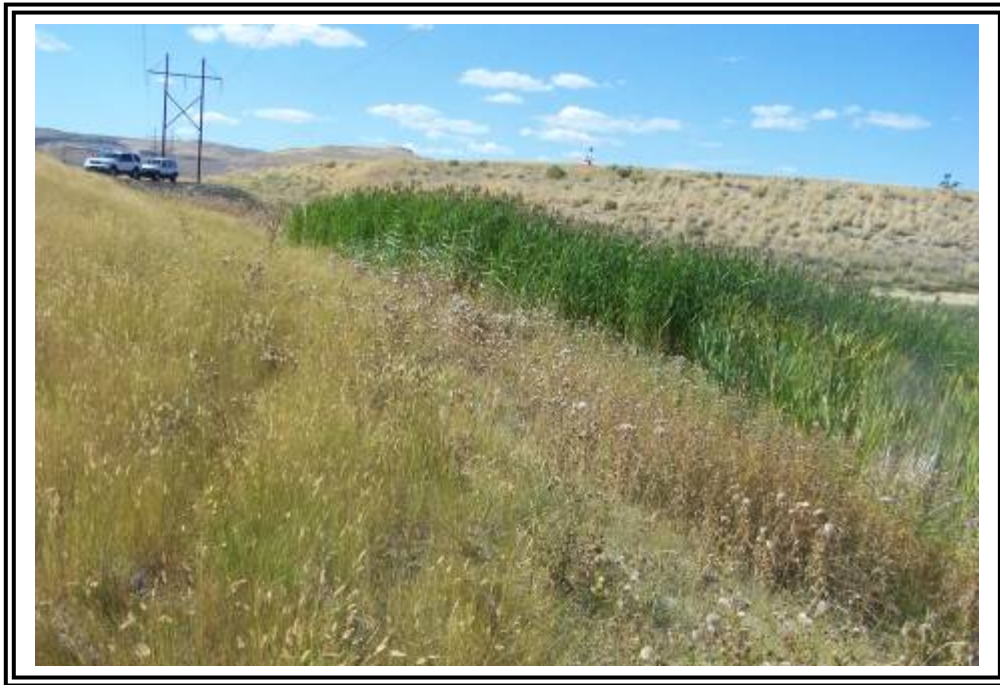
69

Looking toward North Abutment (where vehicles are parked).

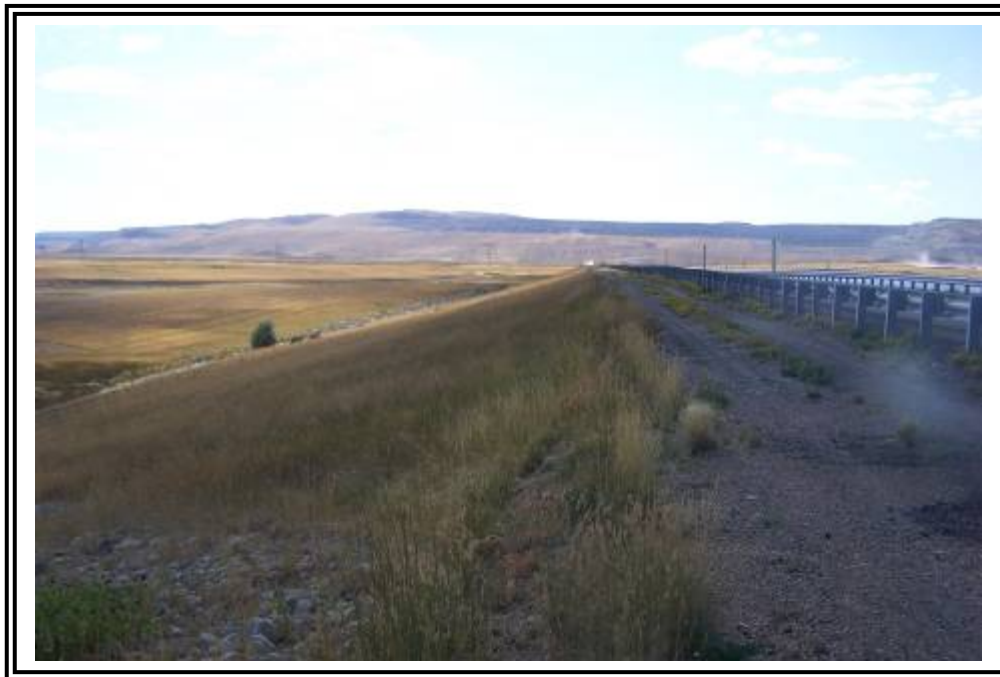
70

Crest/Downstream slope of the Main Dike looking west. Plant access road crosses the Main Dike.

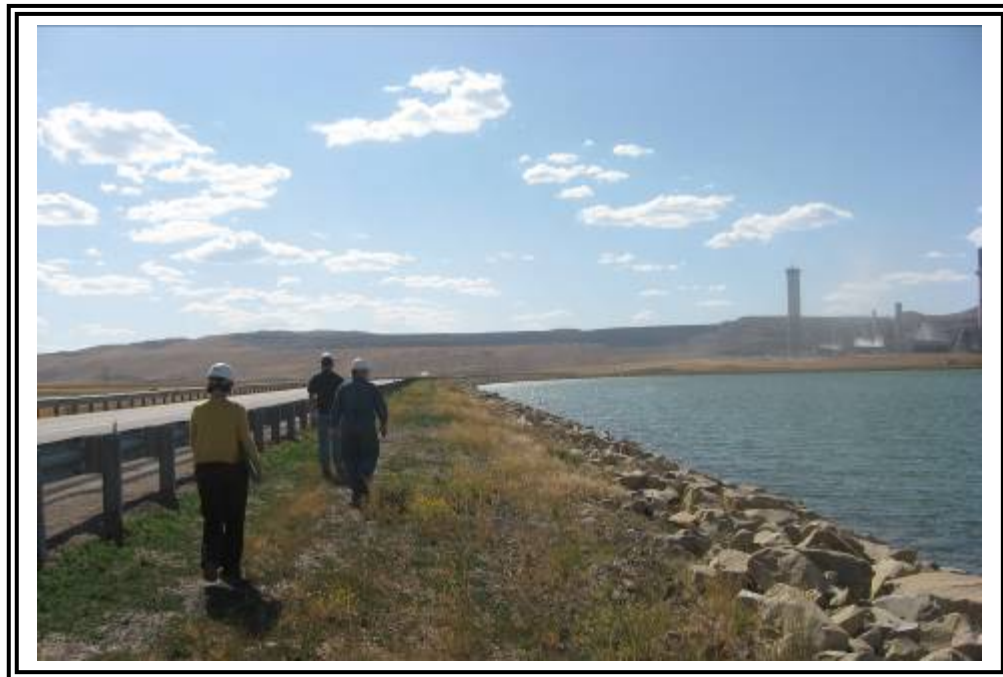
72

Upstream slope of Main Dike looking east.

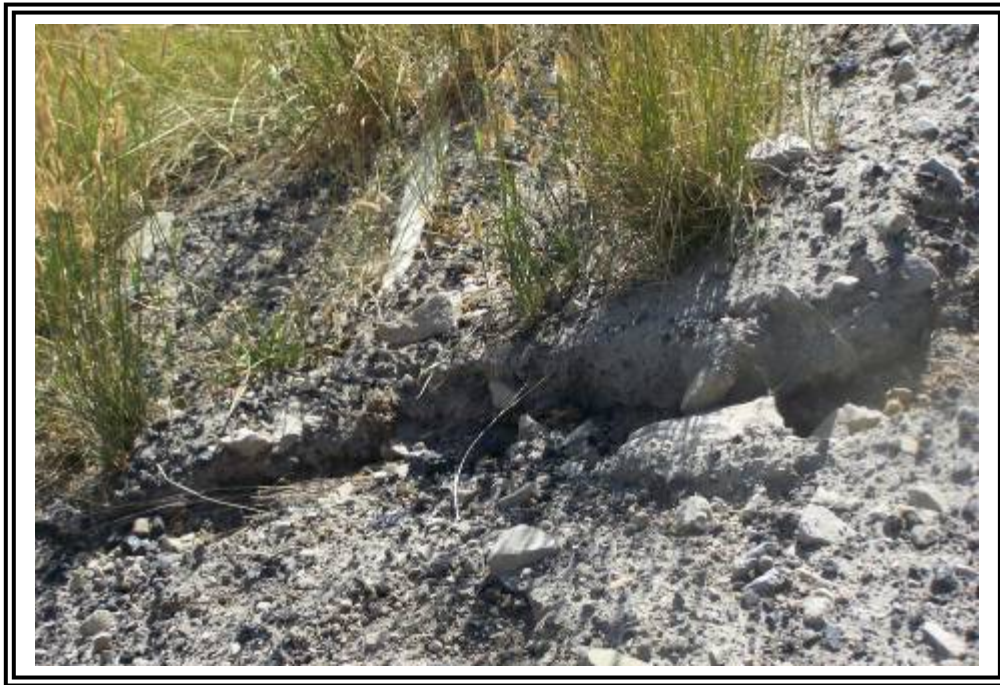
73

Occasional erosion rills, animal burrows, and sage bushes were observed on the downstream slope of the Main Dike. These types of features are shown in Photos 73, 79, and 82. The downstream toe contains a blanket drain that daylights at the toe. This lower area of the embankment is protected with small rip rap.

Occasional erosion rills on downstream slope at crest of Main Dike.

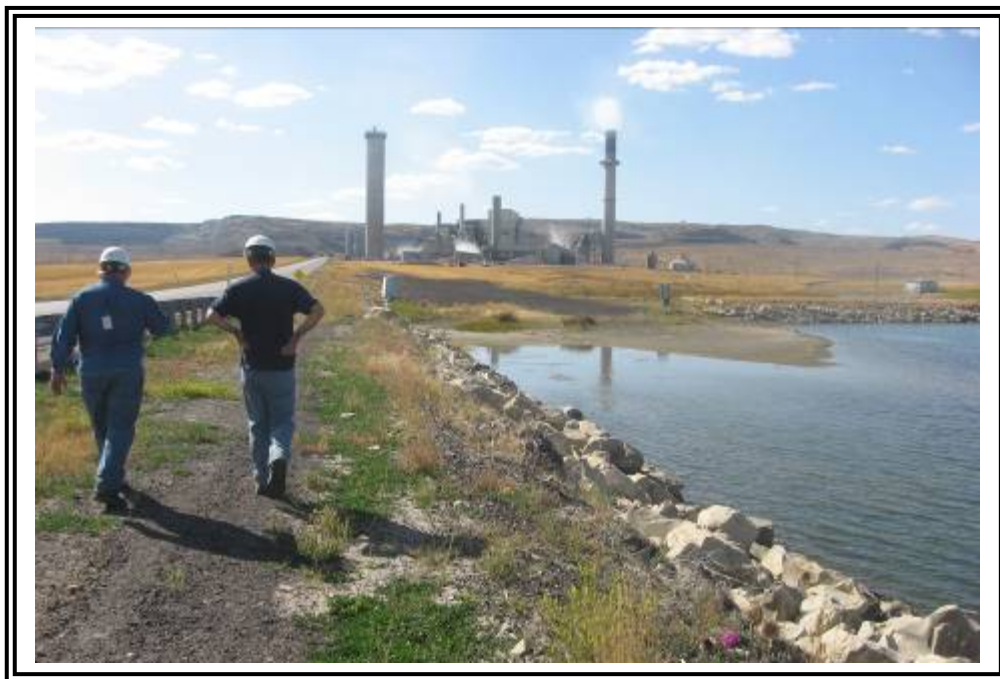
74

Upstream slope of Main Dike approaching west abutment looking west.

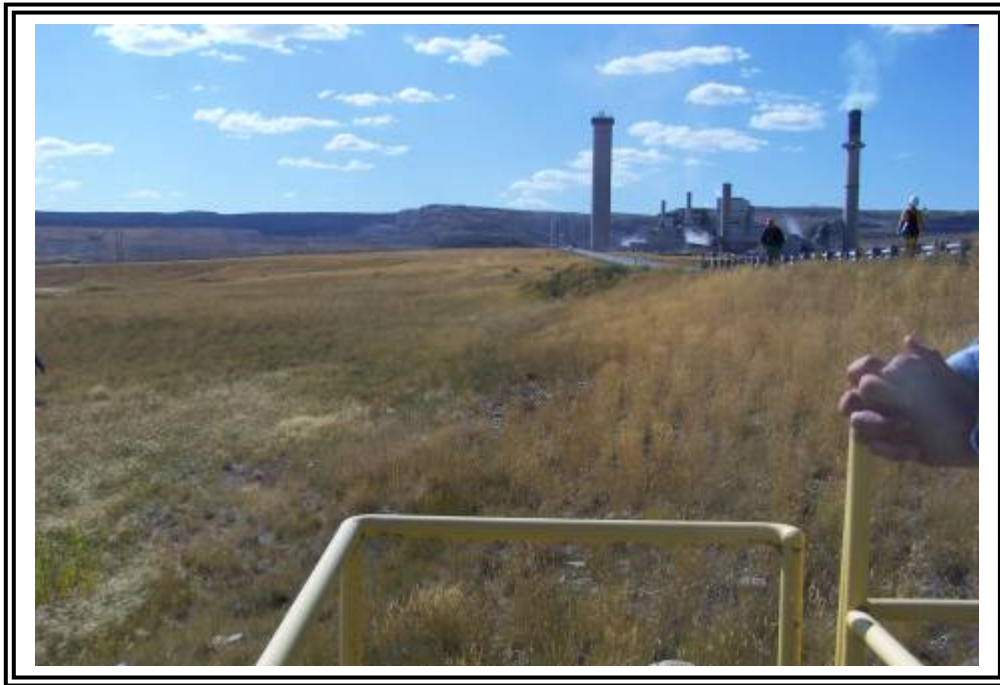
75

Downstream slope of Main Dike looking west from the outfall structure towards the west abutment.

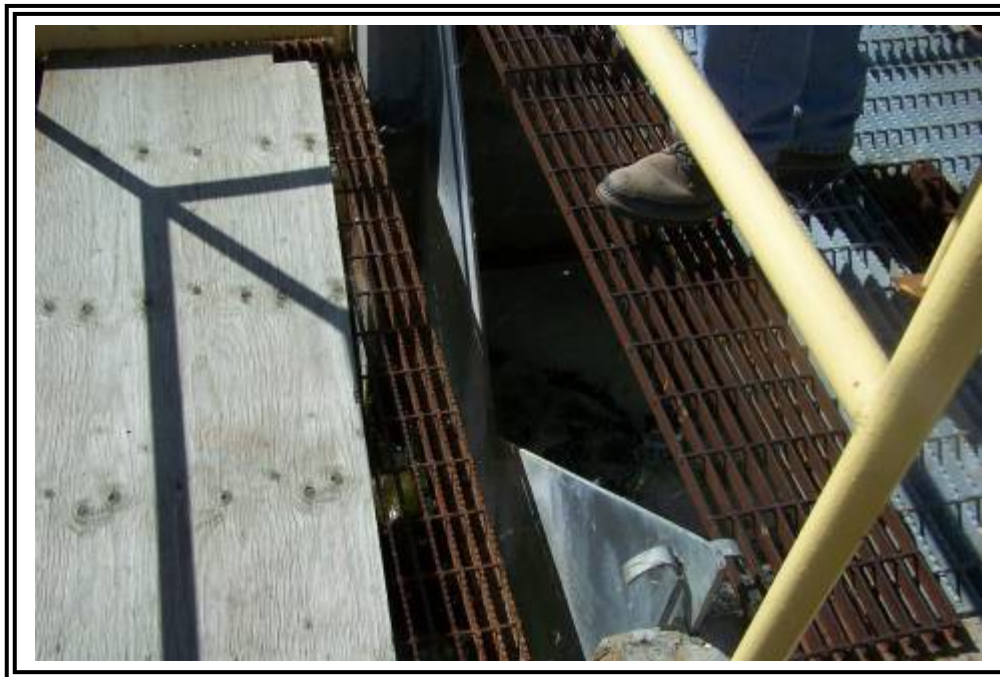
76

Main Dike outfall. During low flow, seeps under weir plate.

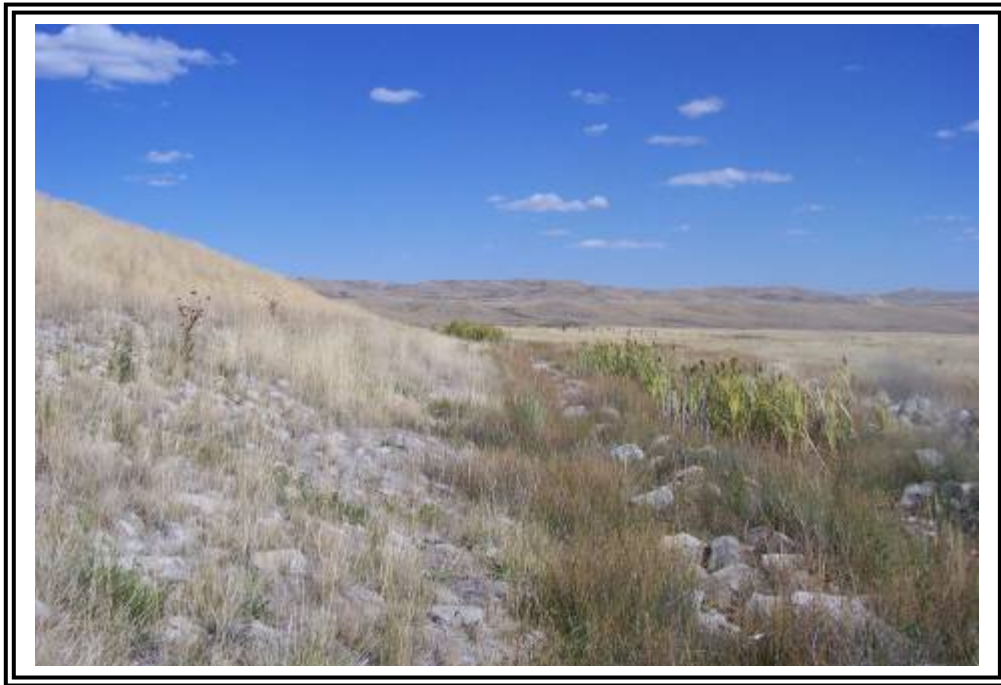
77

Downstream toe of Main Dike looking east. Cat tails are in rip rap lined discharge channel.

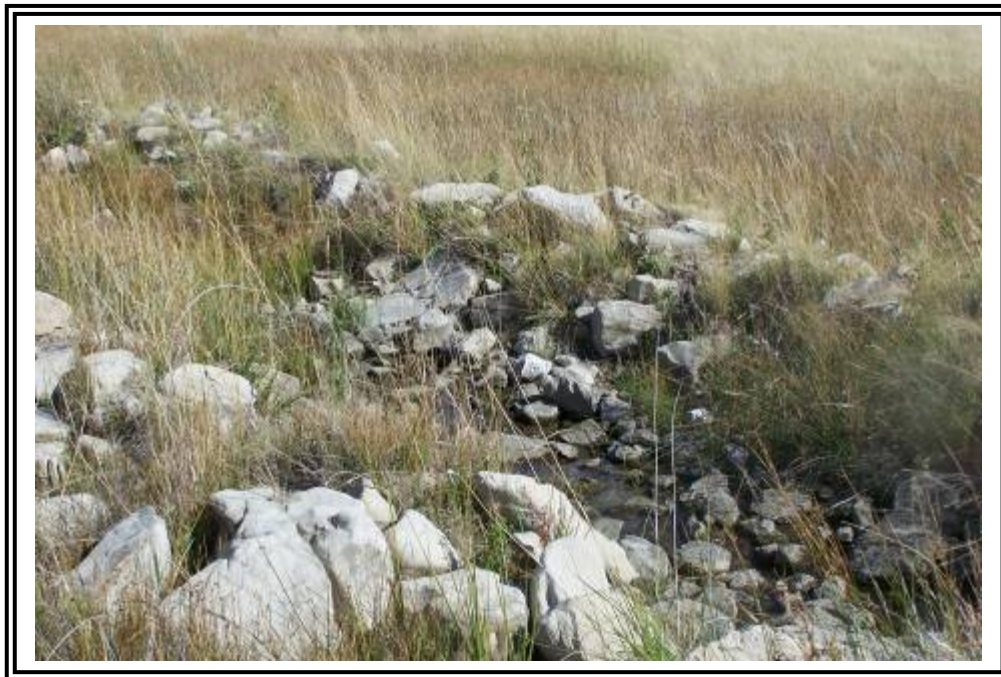
78

Close up of rip rap lined discharge channel from Main Dike outfall.
